EXHIBIT 3

March 8, 2018

Re: M.V. "EAGLE"
Personal Injury - Ms. Amanda Arnold - September 30, 2016
Our Project No. WT-25637

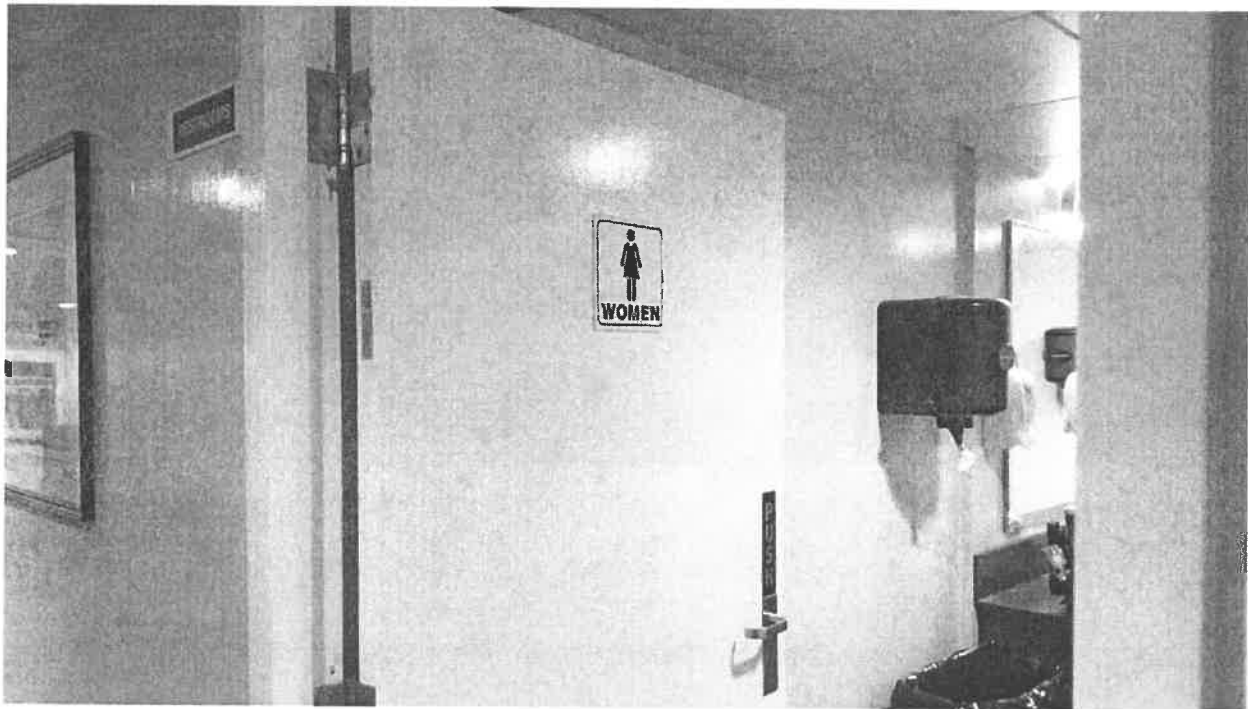
The bulkhead that contains the head doors runs fore and aft, and the women's head door hinge is at the aft edge of the door.

⁴ A smaller crew access door between these two doors closed a little faster but did not slam.

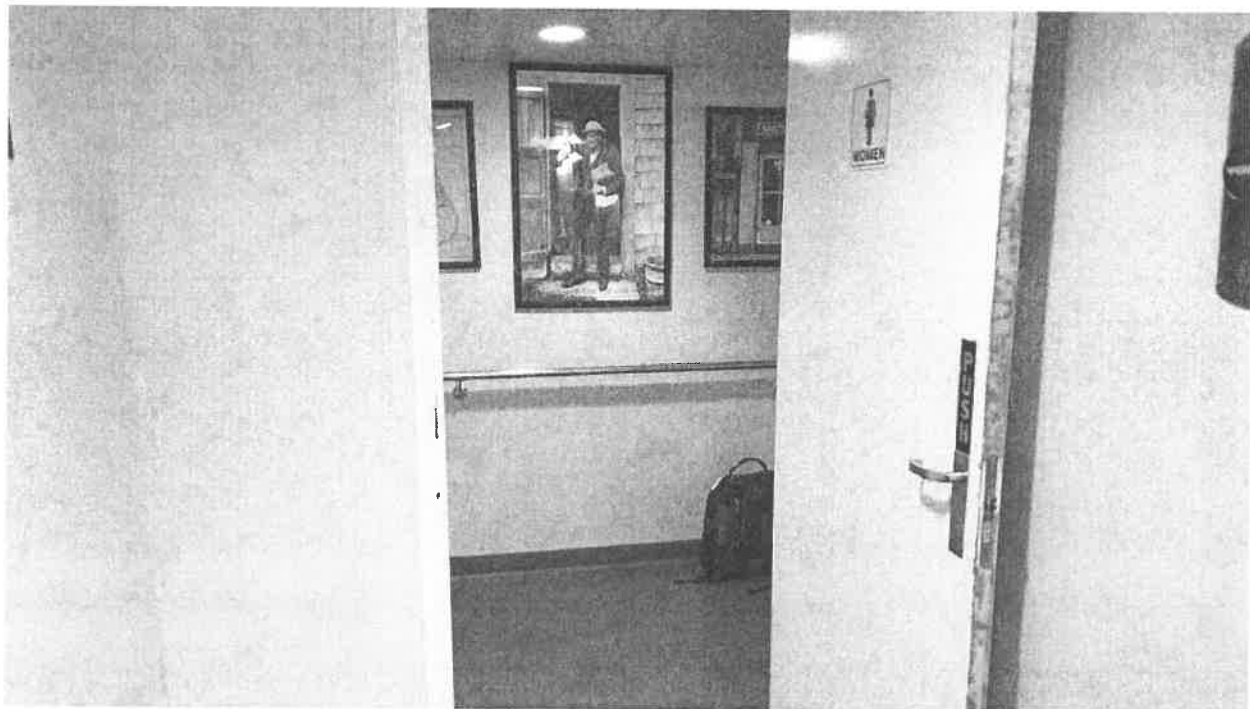
The opposite bulkhead of the passageway has a grab rail outside of the women's head.

There is no grab rail at the bulkhead that contains the doors.

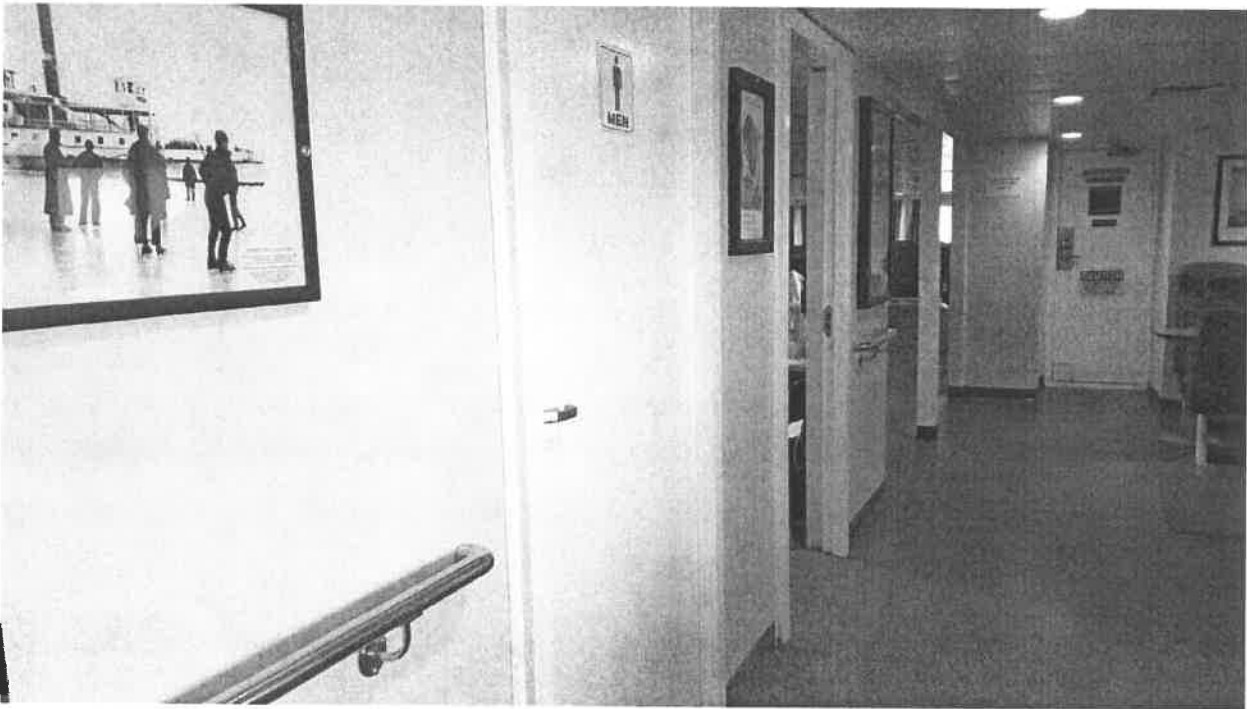
The men's head door hinge is at the forward end of the bulkhead. The men's head has a grab rail on the bulkhead at the lock side but not at the hinge side.

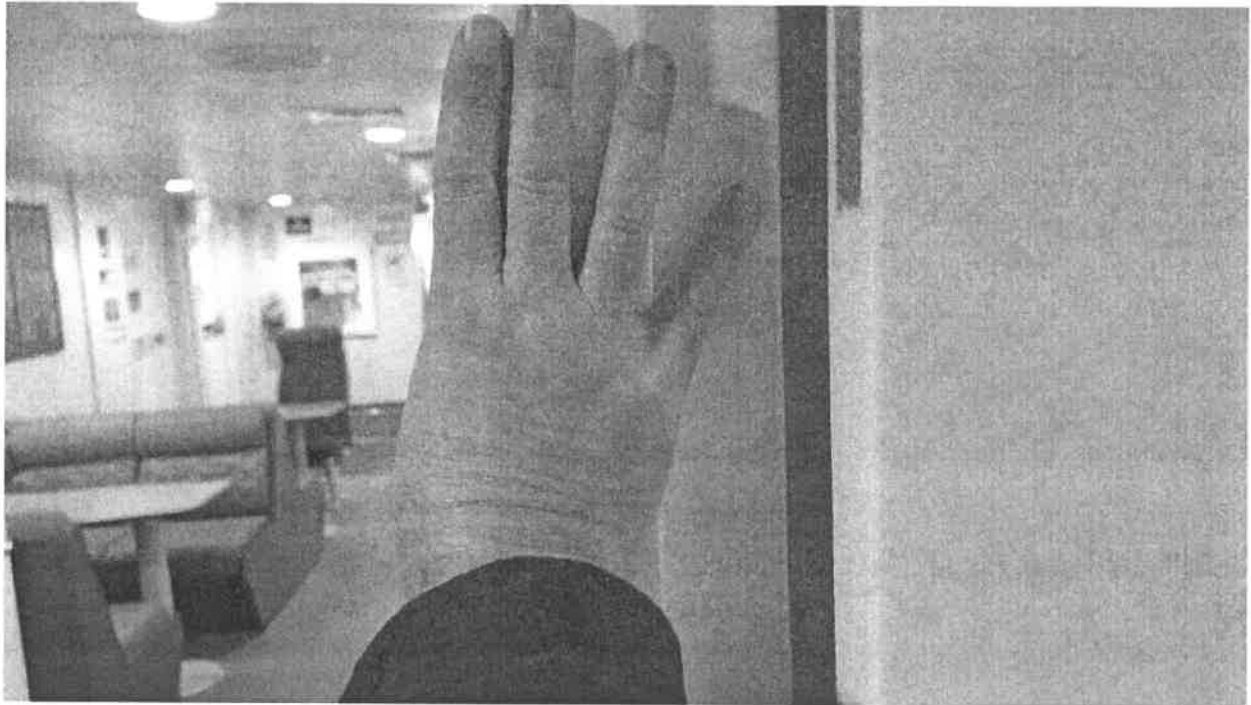
1. The distance from the door to the handrail in the aisle is 5 feet (60 inches).
2. The door width is $37\frac{3}{8}$ inches
3. The door opening at the lock side is $13\frac{1}{2}$ inches by the time a finger inserted in the hinge side jamb starts to get pinched (experience pain). Pinching occurs very rapidly with only a tiny further door excursion.
4. As such, finger pinching will occur prior to the 10-degree door closure limit.
5. When resting a hand on the jamb at shoulder level while standing inside the door opening, a natural right-hand rest would expose the outboard side on the hand (pinky finger) to a pinching hazard, before the ring and middle finger are exposed.

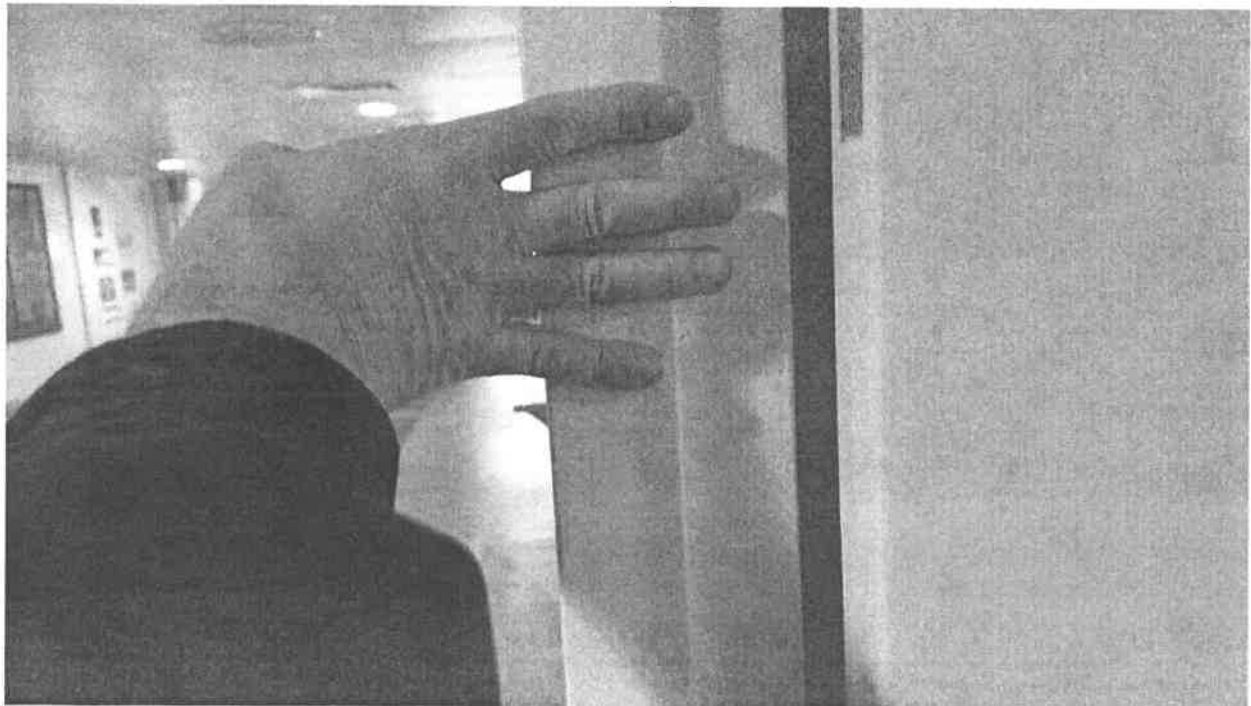
6. Ring and middle fingertip exposure becomes more likely when the person has left the doorway and their body has passed the hinge side of the door towards the bow of the vessel. Then a left and right-hand bulkhead rest against the bulkhead during a vessel roll would expose the middle and ring fingertips first to pinching.
